# **JOURNAL OF GREEN SCIENCE AND TECHNOLOGY**

## **ANALYSIS OF LIGHTNING INTERFERENCE ON THE 500 KV DEPOK-TASIK TRANSMISSION TOWER**

**Windi Pratiwi Putri<sup>1</sup>, Rindi Wulandari<sup>1\*</sup>, Dhany Irvandy<sup>2</sup>**

**Keyword:** *Lightning, Transmission tower, 500 KV Depok- Tasik, Software Falls*

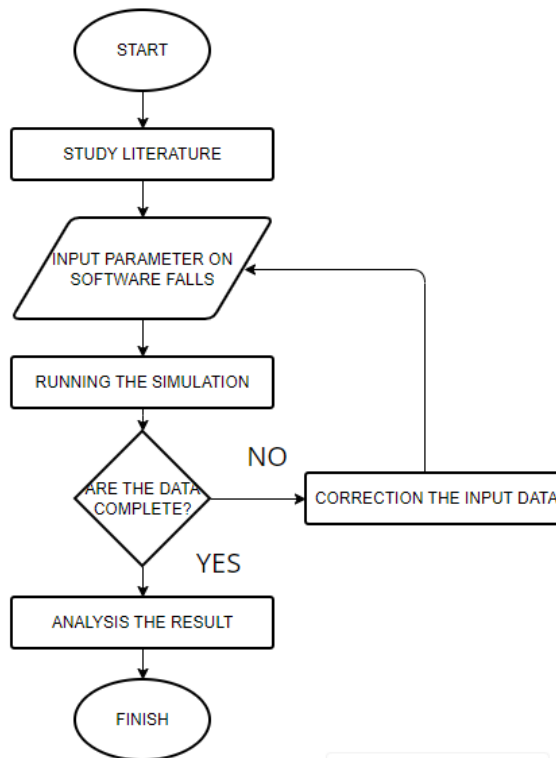
**Figure 2.** Research Flowchart

In Figure 2 shows about how the research process. The process begins with a literature study, the authors study the process of lightning occurrence, lightning protection on transmission lines, the introduction of software falls to study these software falls. Then model all parameters by entering the required parameter data. Then a simulation is carried out and the results are in the form of output data for analysis.

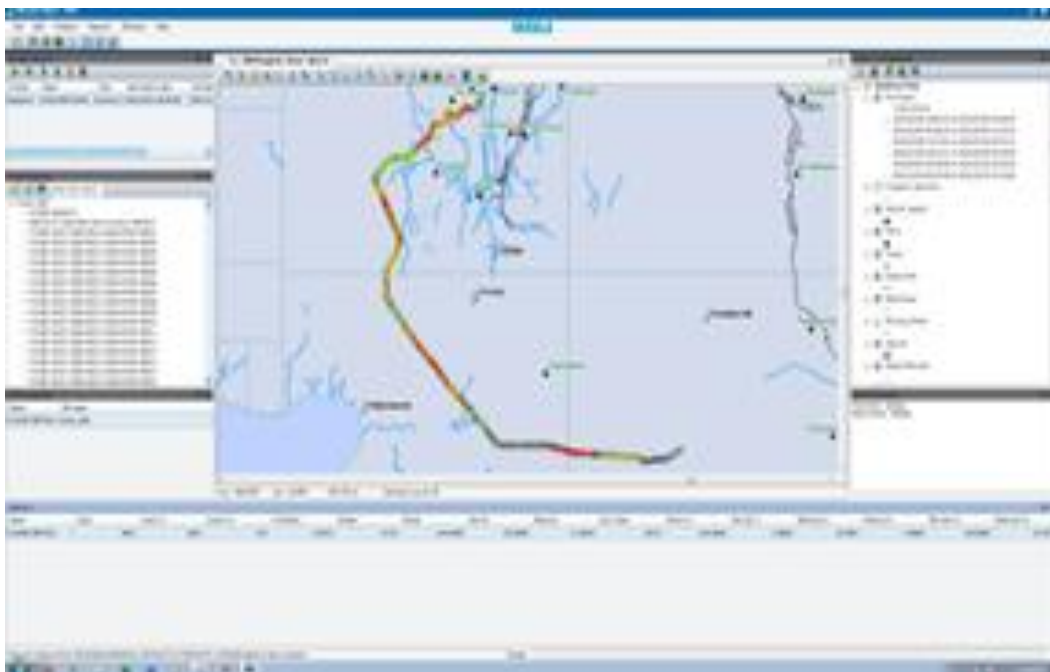
**Figure 3.** Lightning Density Map on the 500kV Depok-Tasik conductor in 2021

The results of the lightning strike hazard analysis using the falls software are shown in Figure 3, there are coordinates for towers with high lightning strike hazards indicated by red coordinates, which means the location of the tower is often hit by lightning.

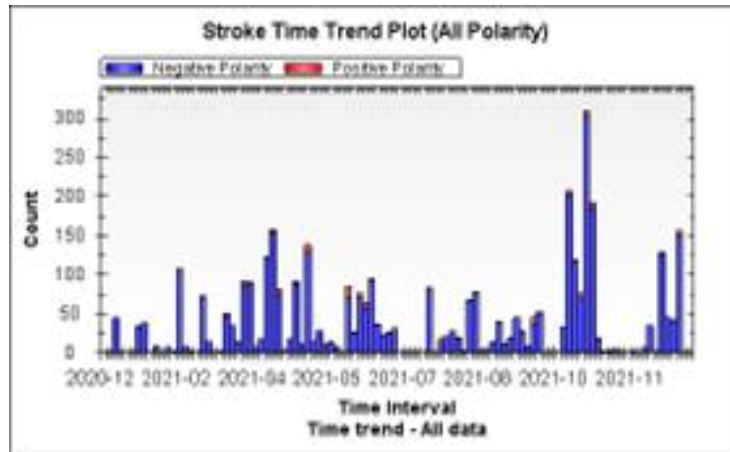
**Figure 4.** Time trend graph for the 500 kV Depok-Tasik conductor in 2021

From Figure 4, it is obtained that the lightning strike hazard data on the 500kV Depok-Tasik conductor surged in October. This is because in October until the end of the year it has entered the rainy season. Lightning occurs more frequently during the rainy season because in these circumstances the air contains a higher moisture content which causes the insulation power to decrease and currents to flow easily, so that the tower is easily struck.

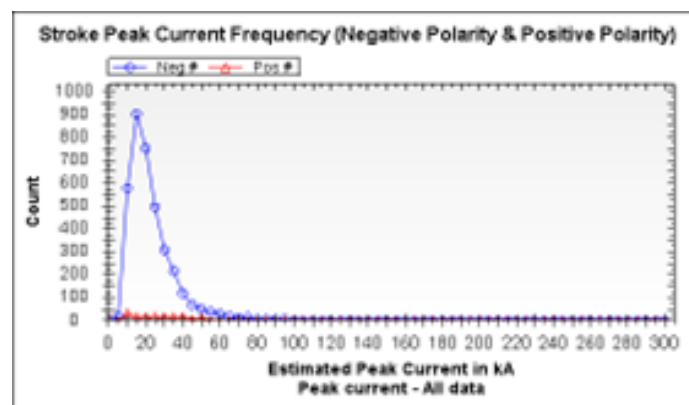
**Figure 5.** Graph of peak current frequency on the 500 kV Depok-Tasik conductor in 2021

1. Peak current frequency 15kA = 600 times Lightning strike (negative)
2. Peak current frequency 20kA = 900 times lightning strikes (negative)
3. Peak current frequency 25kA = 800 times lightning strikes (negative)
4. Peak current frequency 27kA = 500 times lightning strikes (negative)
5. Peak current frequency 30kA = 300 times lightning strikes (negative)
6. Peak current frequency 35kA = 200 times lightning strikes (negative)
7. Peak current frequency 40kA = 100 times lightning strike (negative)

From Figure 5 it can be seen that the highest peak current frequency on the 500kV Depok-Tasik conductor is 40kA and the lowest peak current frequency is 15kA. The highest total lightning strikes occurred at a peak current of 20kA, which occurred 900 times, and the lowest total strike occurred at a peak current of 40kA, which occurred 100 times.

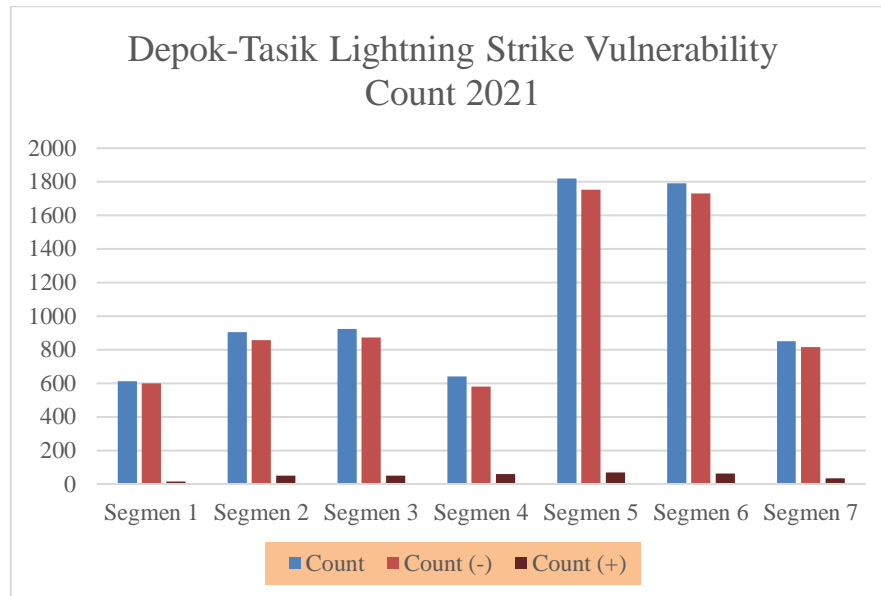
**Figure 6.** Graph of lightning strike hazard data on the 500kV Depok-Tasik conductor in 2021

The 500kV Depok-Tasik conductor is supported by 340 towers starting from tower numbers 326-666. In this study, to determine lightning strike hazard data at tower locations, the authors grouped tower data according to tower locations sequentially. Towers totaling 340 towers are then grouped into 7 segments. One segment consists of 50 transmission towers, with details as follows:

In Figure 6, the data shows that the highest lightning strike hazard occurs in segment 5 (Tower 530-580), namely 1819 strikes and segment 6, namely 1791 strikes. Meanwhile, the lowest lightning strike hazard occurs in segment 1 (Tower 326-276), which is around 612 strikes.
